Sample name: LINK X60

TEST REPORT 249371 / 1

Leg strength test- Side application ANSI-BIFMA X5.1-2017/17

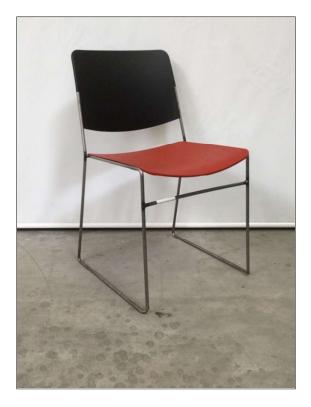
Leg	Applied load N	Load application points mm	Time of application minutes	Remarks
Front leg	503	38 from the bottom and 25 from the edge	1	No defects
Rear leg	503	38 from the bottom and 25 from the edge	1	A partial deformation of the rear left leg near the welding with the seat support has been noticed (see page 2/2).
